Medical Safety
Information

Incorrect Setting of Medication Quantity or Solution Volume on a Syringe Pump

No.119, October 2016

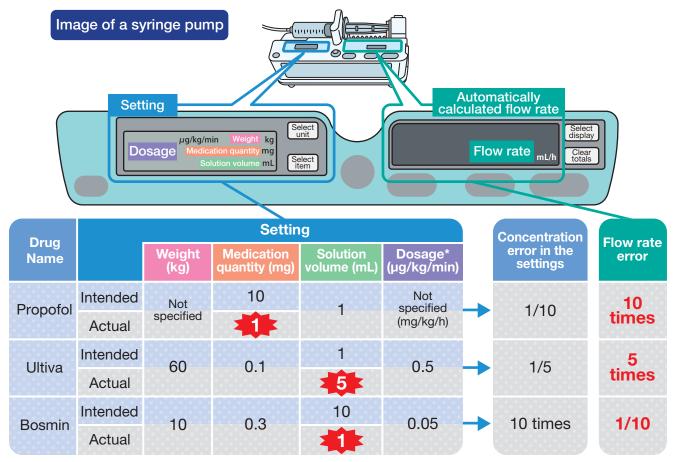
Cases have been reported in which the wrong medication quantity or solution volume was entered on a syringe pump, resulting in the wrong concentration being set and the drug being administered at a flow rate other than that intended.

^{*} Depending on the model, the dosage units may include not only μg/kg/min, but also other options, such as mg/kg/h.

Medical staff will check the medication quantity and solution volume set on the syringe pump immediately before starting administration.

Check whether the calculated flow rate is correct.
