Project to Collect Medical Near-Miss/  
Adverse Event Information

## Medical Safety Information

No.99, February 2015

# Left-Right Mix-Up When Inserting a Thoracostomy Tube

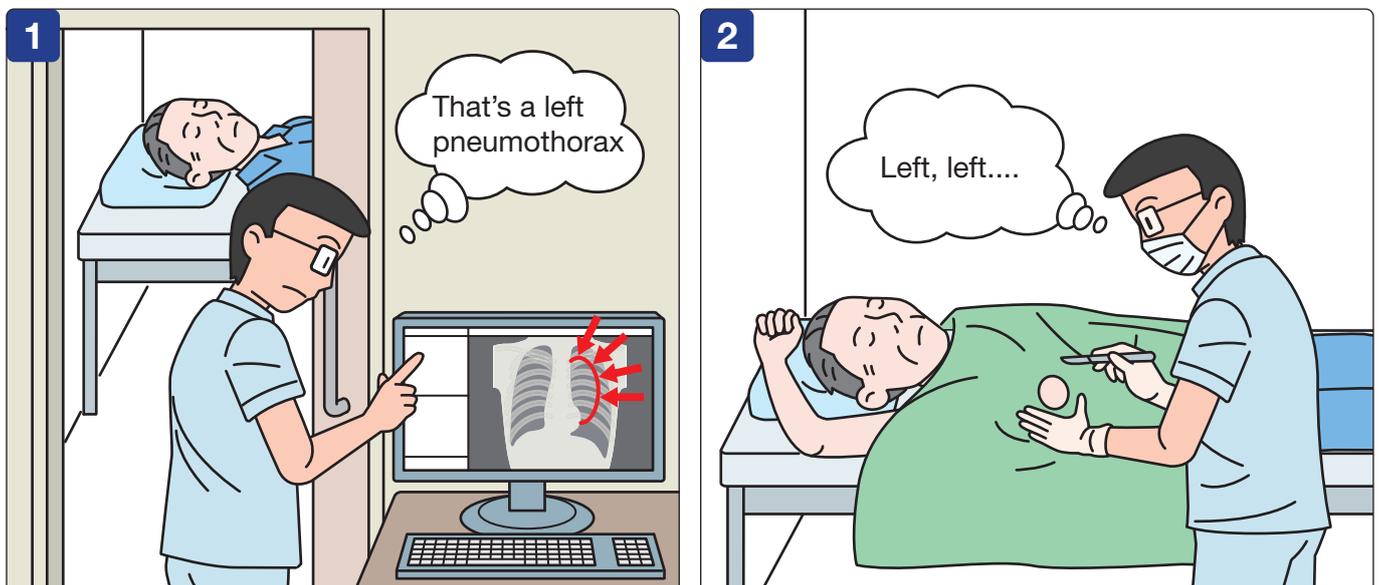
### Image of case 1

**Cases of left-right mix-up when inserting a thoracostomy tube or performing a thoracentesis have been reported. In all of these cases, the medical staff failed to check the site immediately before the procedure.**

A patient with left pneumothorax was to have a thoracostomy tube inserted. Usually, the patient waits in a sitting position and is placed in the position required immediately before the procedure. However, in this case, when the physician entered the examination room, the patient was already lying on the bed in a supine position, oriented in the direction required for performing the procedure from the right-hand side. Assuming that this was the correct orientation, the physician marked the right thoracic area and inserted a drain. The physician subsequently noticed that there was no air leaking from the tube and realized that s/he had erroneously inserted it into the right-hand side.

- The physician and assisting nurse will use images and/or the consent form, etc. to check the patient's name, the puncture site, and the position required when carrying out the procedures.
- The physician will look at the image immediately before the procedure and compare it with the planned insertion site.
